Performance of REBAM® during ball bearing failures

Bearing failure under radial load

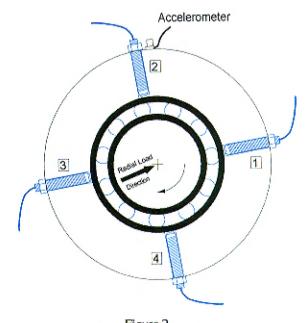
The test bearing was instrumented (Figure 2) with four REBAM® probes mounted 90 degrees apart around the circumference of the outer ring to allow simultaneous data acquisition from multiple probe orientations. The probes were identified as Channels 1 through 4, with Channel 1 being nearest (11 degrees clockwise from) the center of the radial load zone and the other three numbered sequentially in the direction

Figure 2
Test bearing transducer layout.

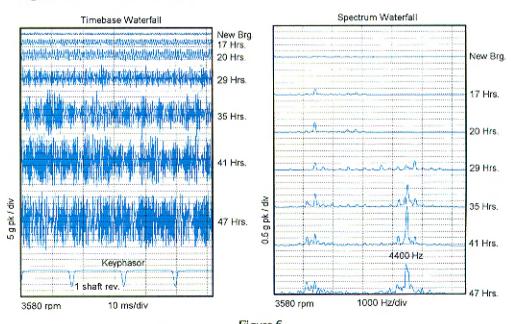
Figure 6
Failure progression under radial loading as seen from accelerometer.

Figure 6 shows the failure progression as seen from the accelerometer. After 17 hours under 3000 lbs (13.3 kN) radial load (when the Channel 1 REBAM® signal started to show damage), the accelerometer signal was already significantly higher in amplitude than the baseline level. The first three samples shown were taken with a bandwidth of 2500 Hz and the remaining samples at 5000 Hz. As bearing damage progressed, the impulse excitation caused by elements impacting

spalled areas excited structural resonances in the system. The first resonance was at about 1400 Hz, and the second (which could be seen in the Spectrum after the recording bandwidth was changed to 5000 Hz) is seen at about 4400 Hz. Transducer resonance was in excess of 50 kHz, and was therefore not a factor. Very little was seen in the accelerometer signal at any of the bearing characteristic frequencies. These components were likely below the noise level of the signal.

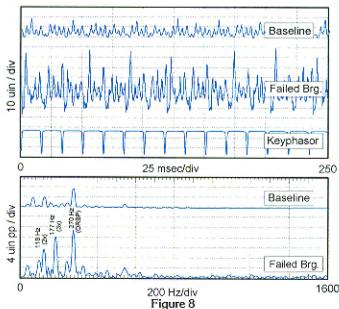
With this in mind, the next step was to use a bearing with extensive spalling and place it under low radial load (300) lbs, 1.33 kN). This was the bearing that was run to failure in the axial load failure test (the data from this failure progression will be discussed in the next issue of Orbit in part II of this article). It contained spalling on the inner raceway and several of the elements. The signal levels were then compared with the baseline levels at the same load. The speed was again 3550 rpm. Figure 8 shows the signal from the Channel 1 REBAM® probe for the baseline and failed bearings. The signal from the Channel 1 probe showed a 130 percent increase in overall signal level, Chan-

Baseline and failed bearing data under 300 lbs. (1.33 kN) radial load as seen from Channel 1 REBAM $^{\circ}$ Probe.

nel 2 showed a 160 percent increase, Channel 3 showed a remarkable 860 percent increase, and Channel 4 increased by 214 percent. The large increase seen on Channel 3 is due to its small baseline amplitude. This shows one very important point: If a REBAM probe is mounted directly opposite the center of the radial load zone in a bearing under pure radial loading, you may not see a large signal when the bearing is healthy or new, but when the bearing fails, it will likely produce enough deflection in the outer ring to produce a large change in signal amplitude. Much of the change occurred at the outer race element pass frequency, but we also see a large change in the components in the rotor frequency region, particularly the 2X and 3X components.
